Historic Properties Management Plan Koma Kulshan Ranger Station

Written by Alana Vidmar
For the use of the Forest Service, Mount Baker-Snoqualmie National Forest

2014

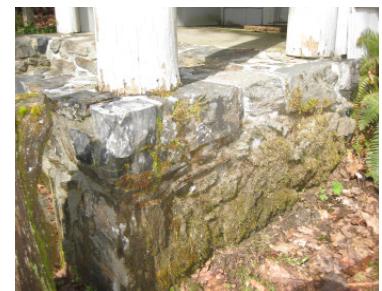
3. After the porch was extended, wooden steps were replaced with masonry steps and porch base. The CCC were well known for their masonry work, and although this work is not original it references typical CCC construction style. In order to upkeep the masonry annual cleaning of the stone and grout is recommended to remove soil and moss with gentle cleaning methods and solutions. Natural debris around the base of the masonry should be cleared often to reduce sources of moisture. For additional work consult the Department of the Interior’s Standards for Restoration of Historic Properties.

Entrance masonry, 2014

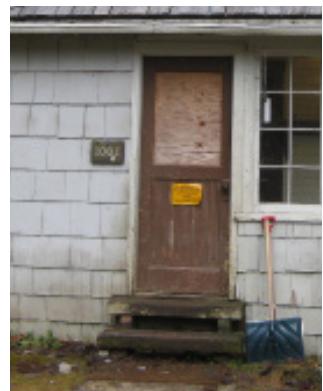
The porch entrance door appears to be the door which was installed when the porch was enclosed. The door would have originally had a glass window, which has since been knocked out and replaced with plywood board. Consider replacing the door with one more compatible with the period of significance. A solid door is suggested if the use of glass is considered a security risk.

The concrete pad and wooden steps leading to the back door should be maintained to avoid degradation. The concrete should be cleared of debris and moss. This can be done by pressure washing the area. The wooden stairs should be scrubbed to clean off moss and treated or painted with a weather resistant paint to protect the wood from moisture and rot.

Rear door, 2014

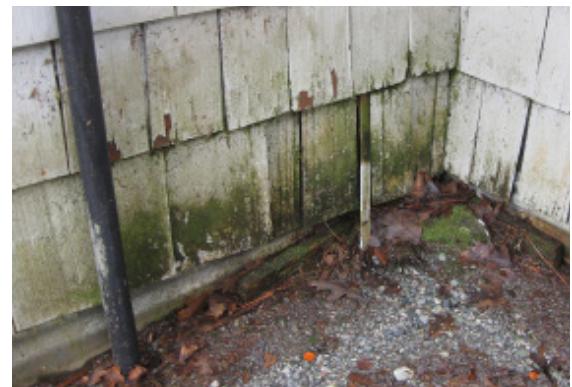
3. The siding shakes have been exposed to weather and moisture, which has caused the lower shakes to grow moss and/or begin to deteriorate. The moss should be gently cleaned as to not damage the paint or underlying cedar shake. The immediate area about the base of the building should be regularly cleared to avoid foundation/low shakes/baseball degradation.

Low siding shakes growing moss because of moisture and uncleared natural debris, 2014

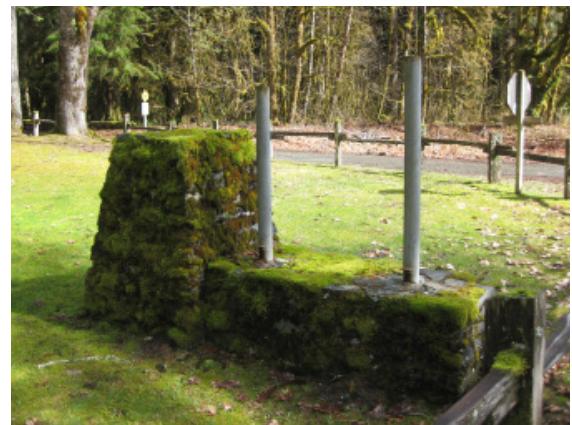
1. A Forest Service station identification sign used to sit off of Forest Highway 11 in front of the Residence. This sign identified the site as Koma Kulshan, and within the Mount Baker-Snoqualmie National Forest. Replacing this sign would both restore a historic feature of the site, as well as act as an interpretive feature for the public. The masonry base for the sign is original, and is indicative of CCC work. In order to upkeep the masonry annual cleaning of the stone and grout is recommended to remove soil and moss with gentle cleaning methods and solutions. Natural debris around the base of the masonry should be cleared often to reduce sources of moisture. For additional masonry work consult the Secretary of the Interior's Standards for Restoration of Historic Properties.

Station identification sign base which is covered in moss and missing the sign, 2014

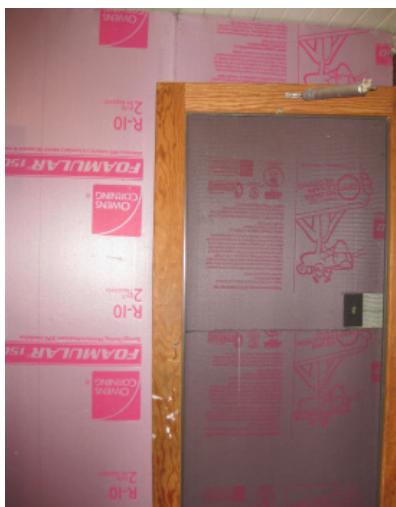
7. Since the Residence was built the back porch has been enclosed. The enclosed porch measures 9'7" x 6' 10". The wood flooring in the enclosed porch is likely the original flooring which would have made up the open porch. The floor is unfinished, or finishing has worn off over years of use. The enclosed porch also features a short bench and storage shelves. These features in their current state work to support the mud-room use of the enclosed porch. Consider finishing the floor to retain the original wood flooring.

Insulation in the enclosed porch,
2014

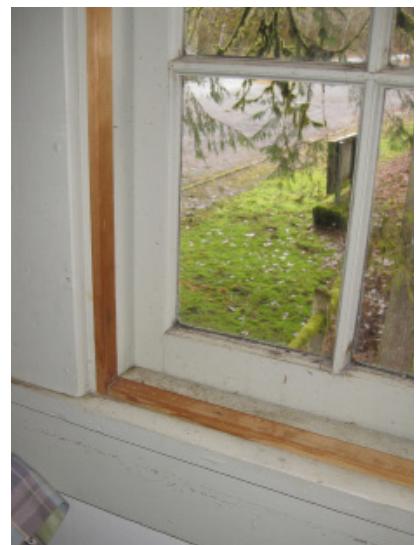
3. In both of the bedrooms wooden frames have been added to the inside of each window to hold screens. These screens allow in air to an open window while not allowing in insects. In the southeast bedroom the frame and screen are intact. In the northwest bedroom the frame exists without a screen. If the screens are not used, the frames should be removed. If the screens are used then a screen should be installed in the frame in the northwest bedroom.

Frame with no screen, 2014

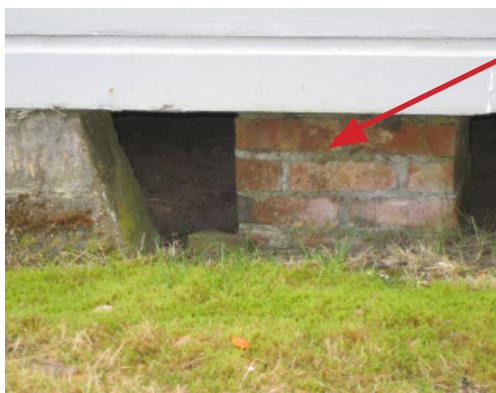
Original brick chimney beneath the building, 2014

3. The original brick chimney was at one time replaced by 16" square standard chimney blocks, which can be seen through the windows on this facade, and above the roof. However, the original red brick base remains below the building between the ground and floor level. This feature should be maintained because it is evidence of the history and transformation of the historic structure. For care, maintenance, and repair of exterior brick features see the Secretary of the Interior's Guidelines for Restoration of Historic Properties.

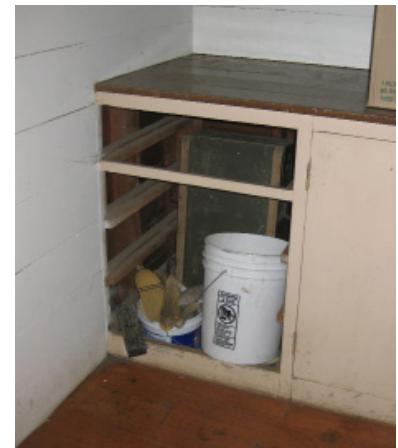
4. An original wooden work counter runs the length of the southeast wall. The counter and drawers beneath seem to be in good condition, but do look used. Four of the 28 pull-out drawers are missing from the northeast side of the counter and should be replaced in kind with the period of significance. Avoiding refinishing the counter will retain the feel of the counter's past use. The drawers beneath the counter should be repainted as necessary.

Four missing drawers, 2014

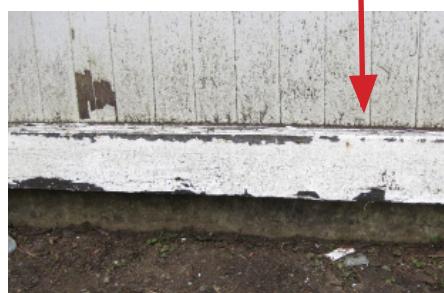
Detail of the base of one of the bay doors, where paint is wearing away due to moisture, 2014

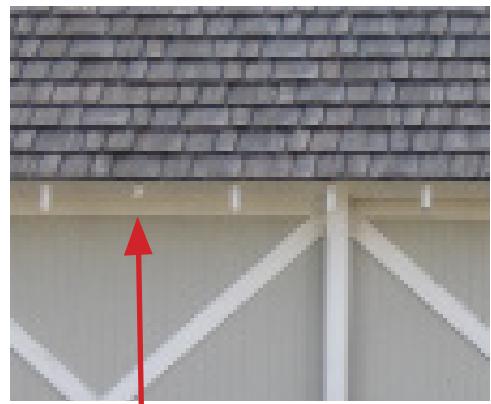
Missing or uneven rafter tails, 2014

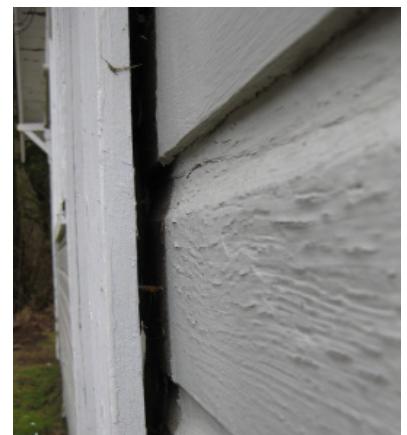
Space between door frame and siding, 2014

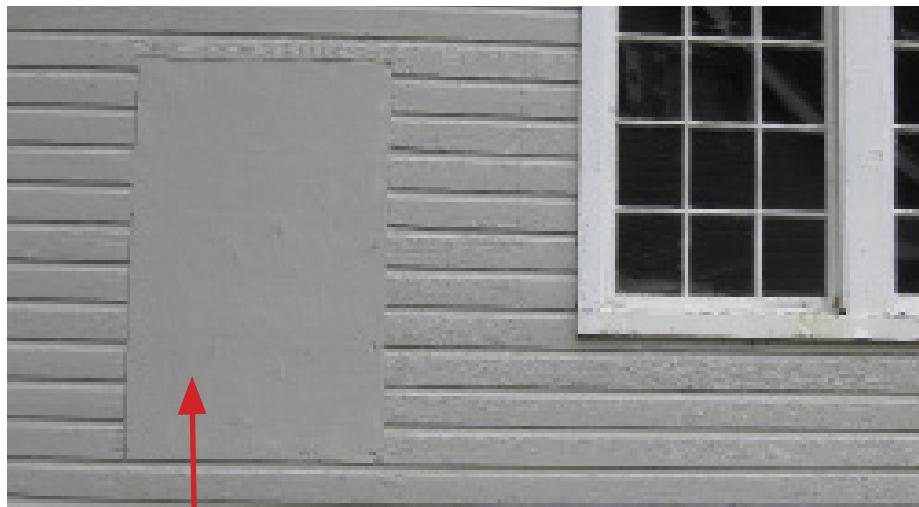
Removed window on southeast elevation, 2014

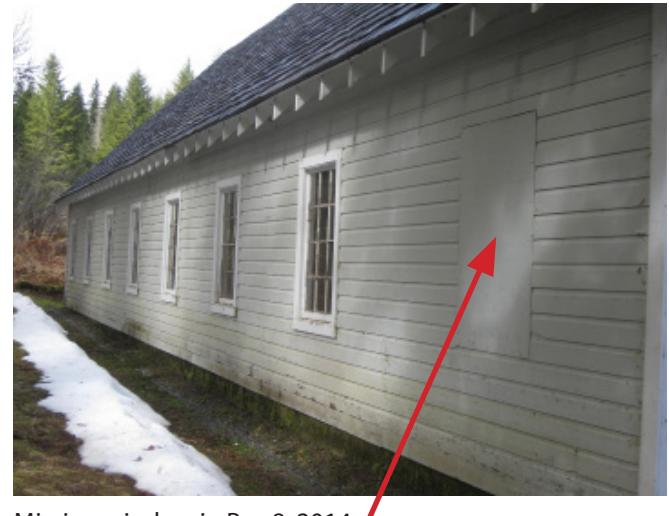
Missing window in Bay 8, 2014

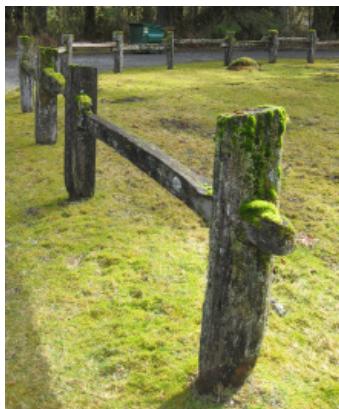
Degrading wooden fence which runs through site, 2014
