Historic Properties Management Plan Koma Kulshan Ranger Station

Written by Alana Vidmar
For the use of the Forest Service, Mount Baker-Snoqualmie National Forest

2014

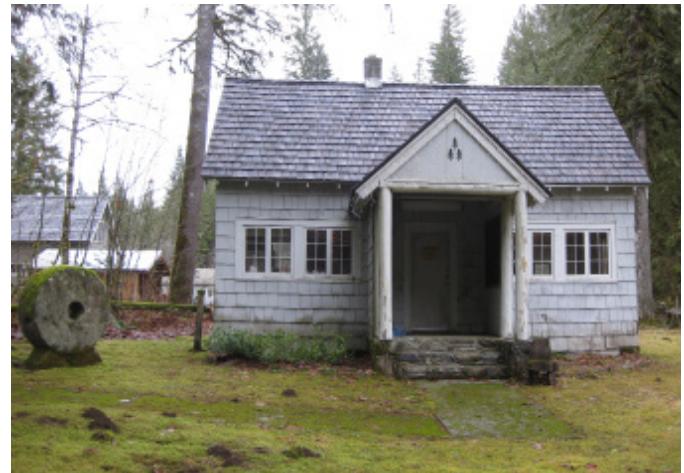
Southwest elevation, 2014

1. Ornamental carvings, which are not original but are in keeping with CCC style.
2. Simple portico entrance with round column supports.
3. River rock masonry porch and stairs, which are not original.
4. Wood materials - cedar shake siding.
5. Windows, which are 3'4" square, true divided light (TDL), 6-pane double-hung.

1. These three ornamental carvings of the “pines” motif are seen in photographs of the Residence as early as 1985, which indicates that the motif was present on the building when the site was listed on the NRHP. The pediment was originally clad in cedar shake, like the siding, and adorned with a plaque (in 1936 the Forest Service shield, and in 1976 a depiction of Smokey Bear with the words “Prevent Forest Fires”). Although not original, the pine symbol directly highlights that the construction was done by the CCC, and it is suggested they be maintained. In order to emphasize the motif the pines may be painted a different color than the pediment, as they are in the 2014 photo, but this is not necessary.

2. In 1978 the porch was extended, but the round columns with no capitals (decorative column tops) remained a feature of the entrance. The entrance is described in the Registration form as a “porch roof supported by two large, tapered peeled poles with notched pole cross-member”. It is unclear if the original poles were kept and re-used when the porch was extended. These poles are a significant feature because they have been retained in the entrance design since the building was constructed. These poles should therefore be retained in any future work or plan to make additions to the entrance. The paint on these poles is currently peeling which over time can degrade the wood. These poles should be stripped of their paint and repainted with a good outdoor paint which will protect the wood from rot and moisture, in order to avoid future replacement of the poles. The new paint should be in keeping with the color scheme of the Residence and the other buildings on the site.

3. After the porch was extended, wooden steps were replaced with masonry steps and porch base. The CCC were well known for their masonry work, and although this work is not original it references typical CCC construction style. In order to upkeep the masonry annual cleaning of the stone and grout is recommended to remove soil and moss with gentle cleaning methods and solutions. Natural debris around the base of the masonry should be cleared often to reduce sources of moisture. For additional work consult the Department of the Interior’s Standards for Restoration of Historic Properties.

5. The southwest facade windows are the same style of window found on the rest of the Residence. The windows are original and because they are replicated around the building are character defining and considered significant features of the building exterior. For care, maintenance and repair of original windows see the Department of the Interior’s Standards for Restoration of Historic Properties.

The entrance portico is enclosed by painted sheets of plywood covered by painted cedar shake. The original entrance was not enclosed which allowed natural light to enter the covered porch. If major work is done to the entrance it is worth considering removing the enclosure to enhance the facade. The front entrance door is not original. Consider replacing the door with one more compatible with the period of significance.

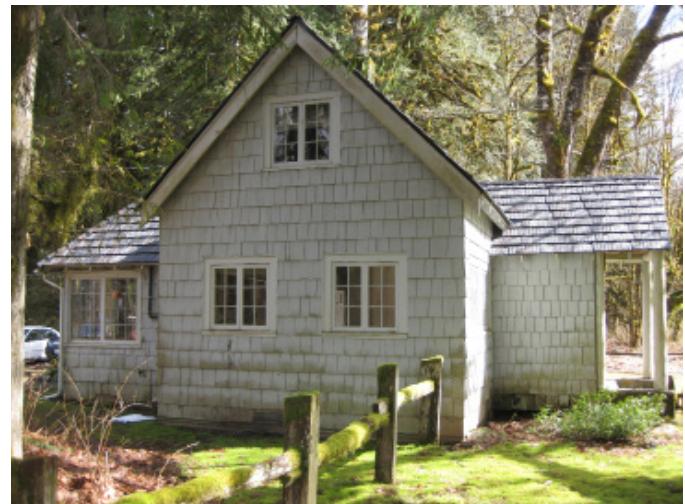
Northwest elevation, 2014

1. The windows are the same style of window found on the rest of the Residence. The windows are original and because they are replicated around the building are character defining and considered significant features of the building exterior. For care, maintenance and repair of original windows see the Department of the Interior's Standards for Restoration of Historic Properties.
2. The enclosed back porch of the Residence is characterized by two sets of these multi-pane windows. Although the full enclosure of the porch is not original, the enclosed porch is listed on the NRHP Registration form, and is consistent with the CCC style. For care, maintenance and repair of these windows see the Department of the Interior's Standards for Restoration of Historic Properties.

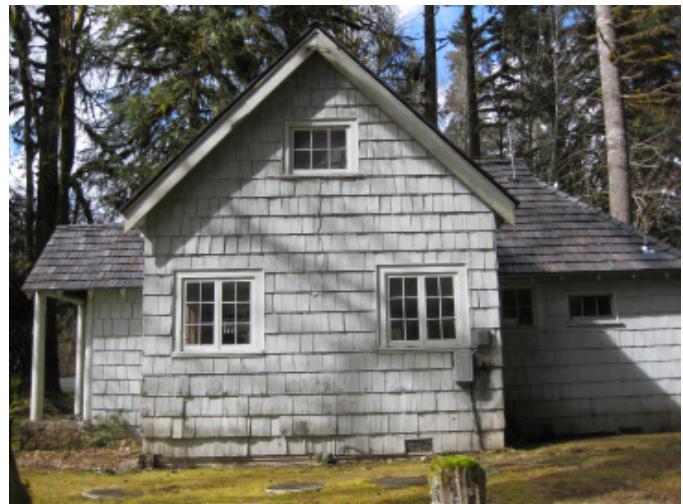
Southeast elevation, 2014

1. One 6-pane single frame square window.
2. Three sets of 3'4" square, TDL 6-pane double-hung windows.
3. One 4-pane single frame square TDL window, measuring 2'1" x 2'3.5".
4. One 3-pane single frame square TDL window.

- 1, 2 & 3. All windows are original. For care, maintenance and repair of original windows see the Department of the Interior's Standards for Restoration of Historic Properties.
4. This window, located in the bathroom of the Residence, appears to be a replacement in kind rather than an original feature. It is in good condition and should be maintained.

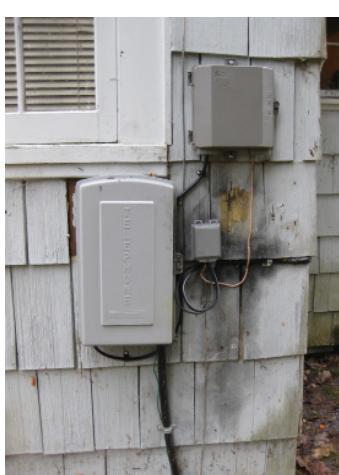
Southeast elevation, 2014

Attached to this side of the Residence there is a telephone box. Installation and removal of other systems in this location is the likely cause of the damaged cedar shake siding, which created char marks on the building exterior. Efforts should be made to protect the siding from further damage. The affected shakes should be repainted. If the cause of the charring is unknown, repaint shakes and monitor area for changes.

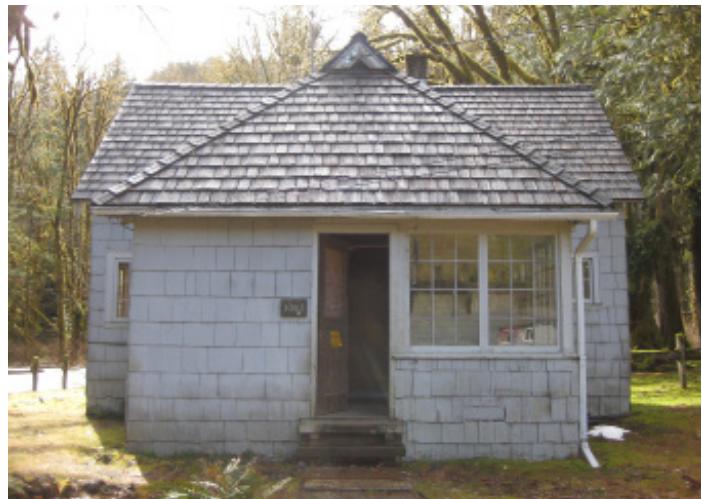
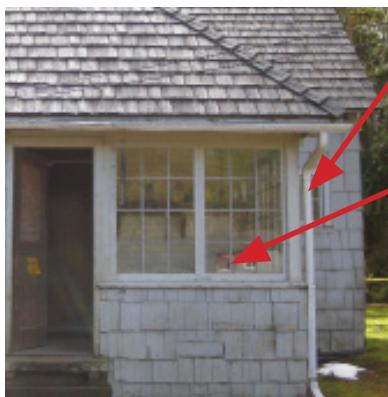
Northeast elevation, 2014

1&2. These windows are original. For care, maintenance and repair of original windows see the Department of the Interior's Standards for Restoration of Historic Properties.

The porch entrance door appears to be the door which was installed when the porch was enclosed. The door would have originally had a glass window, which has since been knocked out and replaced with plywood board. Consider replacing the door with one more compatible with the period of significance. A solid door is suggested if the use of glass is considered a security risk.

The concrete pad and wooden steps leading to the back door should be maintained to avoid degradation. The concrete should be cleared of debris and moss. This can be done by pressure washing the area. The wooden stairs should be scrubbed to clean off moss and treated or painted with a weather resistant paint to protect the wood from moisture and rot.

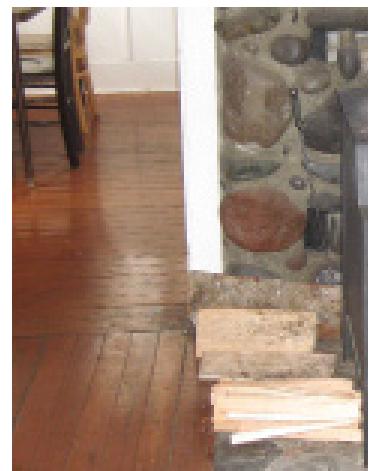
1. The living room and hallway of the Residence still retain the original wood flooring, which is consistent with the style of wood flooring used in the FR&T building. The living room floor was refinished around 1972 after the building was vandalized and a small fire was lit on the floor. These areas of wood flooring are part of the character of the building, and should not be permanently covered (throw rugs which protect the wood are acceptable) or painted. Care should be taken when moving heavy objects across the floor to avoid scratches or damage to the wood. If it is found to be beneficial to the floor, flooring in these areas of the Residence can be refinished.

Original wood flooring, 2014

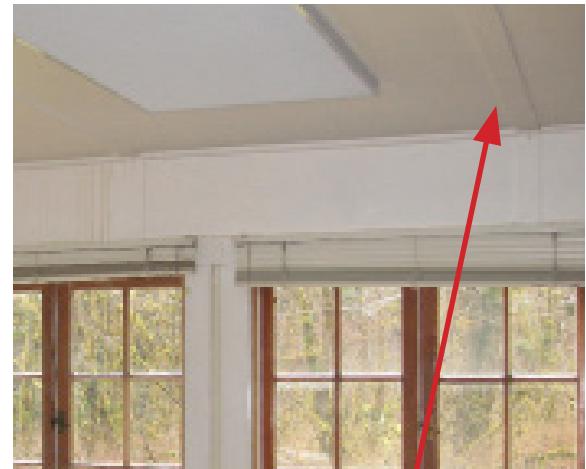
2. The original plywood and batten walls and ceiling can be found throughout the Residence first floor. The walls and ceiling were likely not originally painted, based on examples found in similar Civilian Conservation Corps (CCC) projects from this time period. The walls and ceiling were likely made of unpainted finished plywood, which has now all been painted white. Plywood was a common and accepted building material in early 1900s Forest Service construction. Ply and batten is easy to install, and is therefore a material often used by young and untrained CCC crews in the facilities they constructed. This construction feature is indicative of the time period and CCC construction. Plywood is susceptible to moisture, which can cause damage to the layers of wood, so clean walls and ceiling with a damp cloth (Wilson, 2007). Take care to keep space between items like tables and chairs and the walls to reduce the risk of damage. If the walls and ceiling need to be repainted, consider instead stripping the paint and refinishing the bare plywood if this can be done in a way that does not harm the wood.

Plywood & batten style is consistent throughout the Residence, 2014

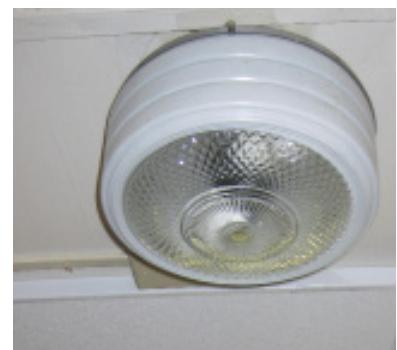
3. Although the light fixtures have been updated and are not original, the light fixtures are likely in their original location within the Residence. Lighting is relatively minimal. If more lighting is found to be necessary, consider a non-permanent solution like a lamp, which does not affect the wiring system of the building.

Current light fixtures are likely in original locations, 2014

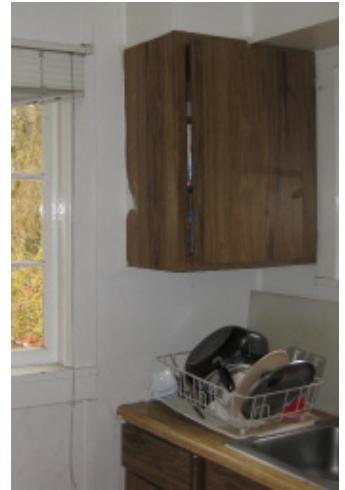
Current kitchen features are simple, but not original, 2014

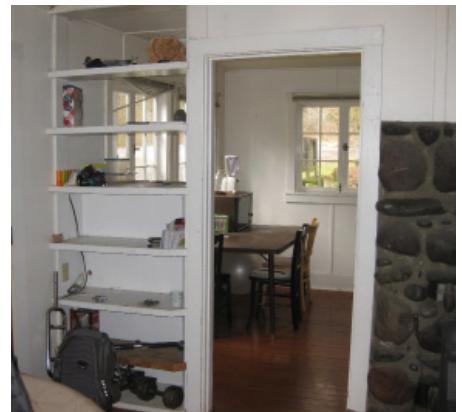
Open divider between living room and kitchen, 2014

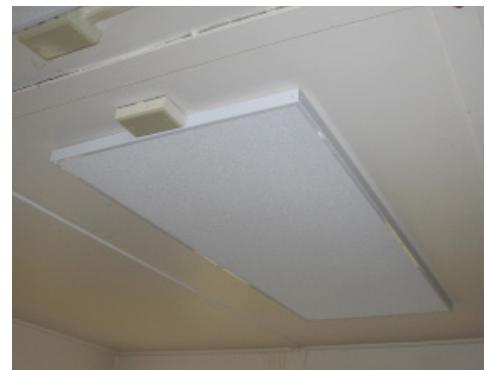
6. Radiant heating panels were installed in the living room (2), kitchen (1), and bathroom (1) approximately two to three years ago. The heating panels are controlled by a thermostat to add an additional heating source to the building, which is useful for residents living in the building in colder months. Although the panels are close to the ceiling and match the ceiling color, continue to look for heating options which will be more efficient and visibly more subtle or in keeping with the period of significance.

Heating panel on first floor, 2014. There are 6 panels total in the house.

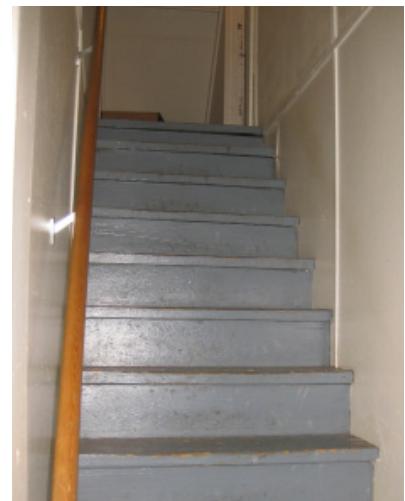
1. The original 13 step staircase ascends from the wallway of the first floor to two attic bedrooms. The stairs have the original wood flooring, which has been painted. Care should be taken to retain the quality of the wood by protecting the floor when moving heavy objects up and down the stairs, and refinishing or repainting the floor as necessary to prevent scratches and wear on the floor.

Original 13 step staircase, 2014

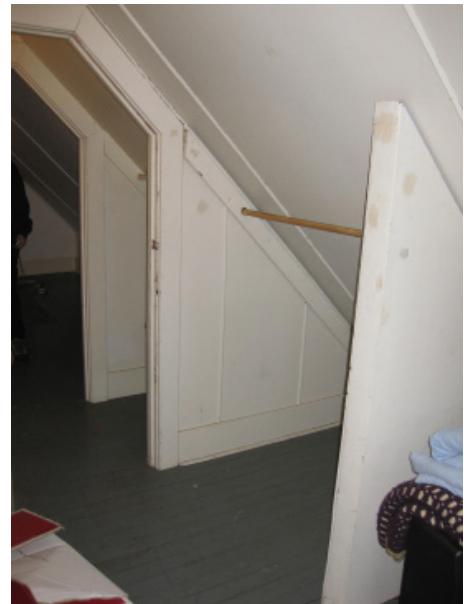
1. A 4'x 4' closet space has been constructed in the northwest bedroom, with a rod to hang clothes on. This division of space was likely not original since the wall type does not match the ply and batten style of the original walls. However, this permanent space divide acts as a storage area for residents and may remain.

4'x 4' closet in northwest bedroom, 2014

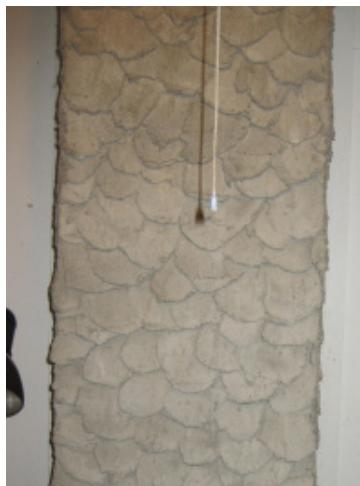
Concrete chimney in northwest bedroom, 2014

2. The concrete chimney runs through the northwest bedroom along the southeast wall. If the chimney or hearth material is changed, the chimney material should be changed to match, as it currently does not fit the historic character of the building.

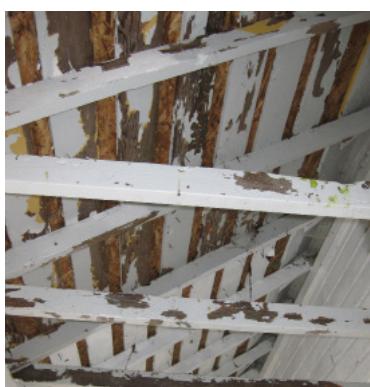
Eaves which support the elongated roof, 2014

1. The roof extension was not a part of the original design, but was constructed between 1936 and 1942 to protect the porch which extends out from the face of the building. The four square posts, which have chamfered corners, support the extended roof and are in good condition, but should be monitored for signs of degradation. Care, maintenance or replacement should be in keeping with the period of significance. The eaves which support the extended roof should be repainted, as the paint is chipping which leaves the wood unprotected. The roof was recently replaced in 2013. (For comments on maintaining the roof see Residence "General Exterior Features" #2).

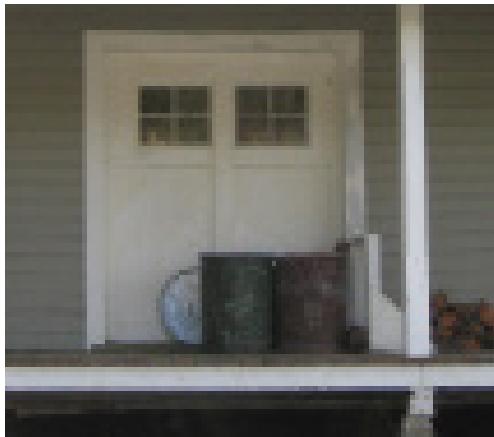
Original sliding door, northeast elevation, 2014

3. This sliding loading door is significant because it communicates the historic use of the building as an equipment storage facility. The door is in good condition, and should be maintained. Clearing the space in front of the door would highlight this feature, as well as decrease the risk of collecting moisture or physically damaging the door. The windows in the sliding door match windows in this facade and should be cared for and maintained.

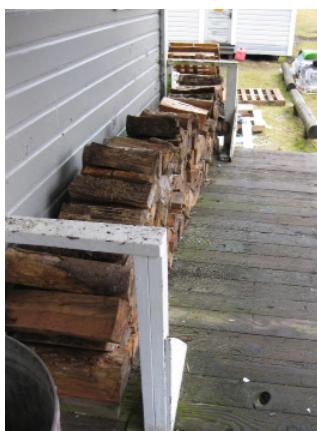
Wood storage on porch, northeast elevation, 2014

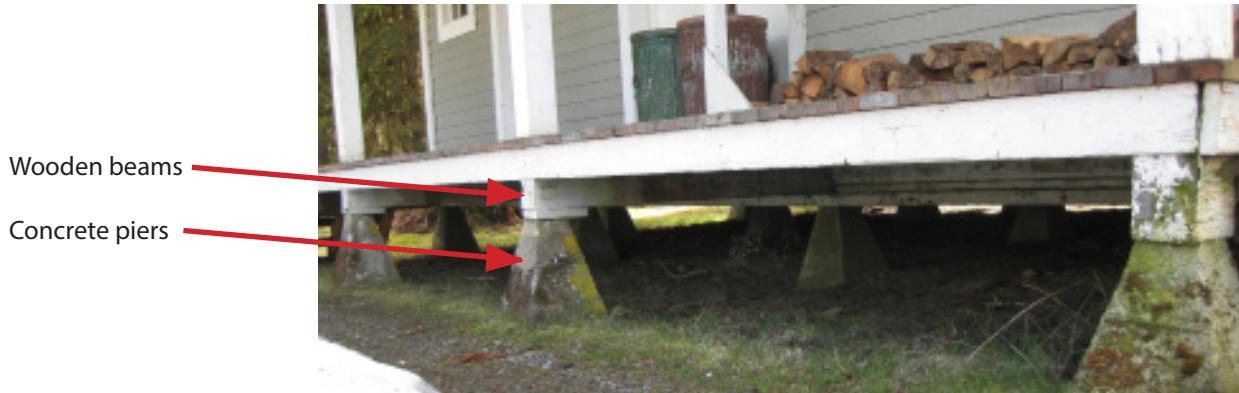
1. The FR&T chimney was replaced, baring the base below the building, but has remained in the same position on the roof, as seen in historic photographs. The chimney should not be moved or repositioned unless it is found to be necessary.
2. The raised pier foundation on this building is unique to the Koma Kulshan Ranger Station site. The raised floor helps to keep the base of the building dry and decreases the risk of deterioration. The concrete piers are original and have remained in good condition. The wooden beams are in good condition, but should be regularly checked for signs of degradation.

Foundation of the FR&T Building, 2014

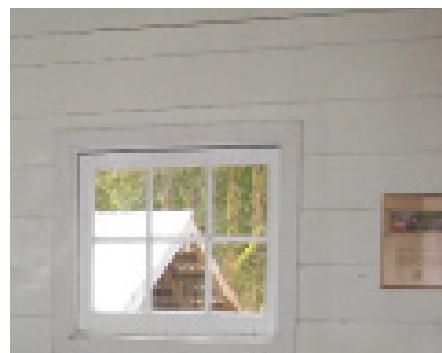
2. The interior wall cladding is painted horizontal board siding, which matches the exterior cladding. The horizontal boards should not be obscured or covered, and should be kept clear of heavy materials in order to avoid risk of damage to this original feature. Scuffs to the paint can be painted over using the same color to decrease the look of wear.

Horizontal board cladding, 2014

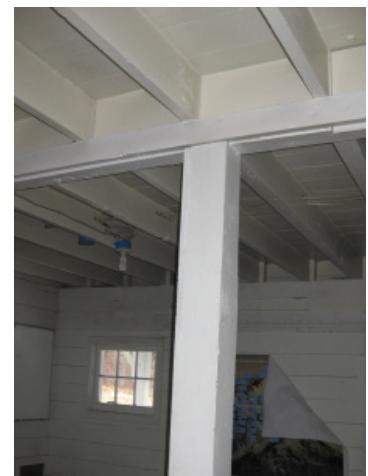
1. The FR&T Building features exposed structural elements on the first floor including the ceiling beams and vertical supports poles. These elements are important to retaining the warehouse feel of the building. These features are currently painted and appear to be in good condition. No effort should be made to cover or detract from these features. The beams and poles should be regularly checked to assure that they are not deteriorating. Repaint as necessary.

Structural elements, 2014

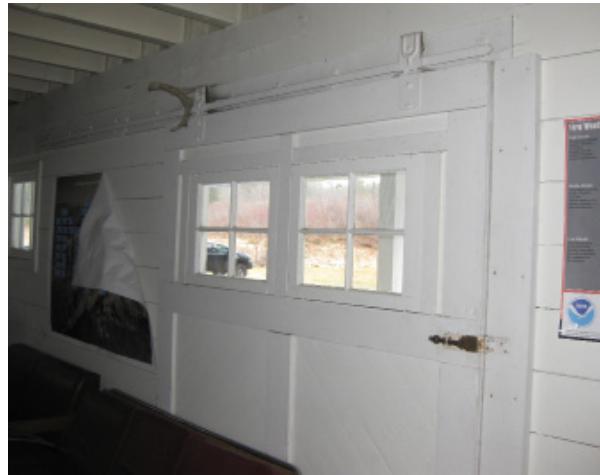
Original sliding warehouse door, 2014

3. The sliding warehouse door centered in the northeast facade of the building is indicative of the historic use of the building. This area directly in front of the door should be kept clear to avoid damage to the wood. The original door and hardware should be maintained, and the door should be kept in working order.

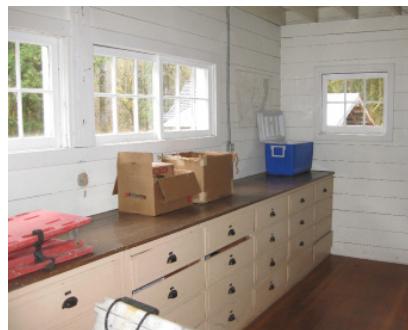
Counter along the southeast wall, 2014

4. An original wooden work counter runs the length of the southeast wall. The counter and drawers beneath seem to be in good condition, but do look used. Four of the 28 pull-out drawers are missing from the northeast side of the counter and should be replaced in kind with the period of significance. Avoiding refinishing the counter will retain the feel of the counter's past use. The drawers beneath the counter should be repainted as necessary.

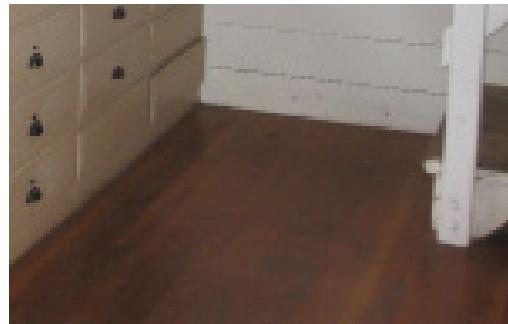
5. The FR&T Building still features original unpainted wood plank flooring. The floor has been maintained and is in good condition. The flooring should remain unpainted, since a building of this use in the period of significance would not have had a painted floor because the paint would be damaged. The floor should be refinished when found necessary in order to protect the wood. This flooring is indicative of a working building, and the overall appearance of the floor gives the impression of a history of use.

Original wood flooring, 2014

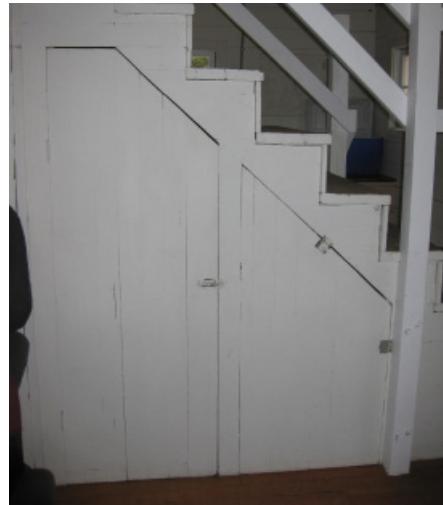
6. The base of the stairway which leads to the second floor of the building features cut-out doors which are likely original. These doors open into a storage area beneath the stairs. This storage area can continue to be used, but the immediate area should be kept clear in order to avoid damage to the staircase and the cut-out doors.

Cut-out storage areas in the staircase, 2014

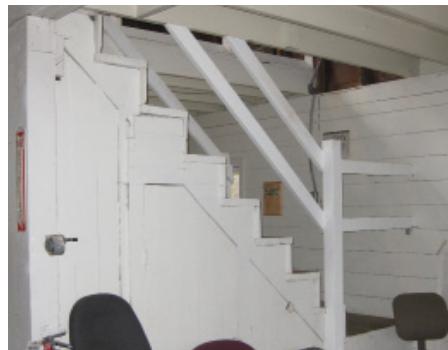
Staircase railing, 2014

1. Railings have been added to the staircase in order to meet safety requirements. The current configuration with railings are an accepted change and do no significantly detract from the feel of the interior. The railing should be occasionally checked for structural stability.

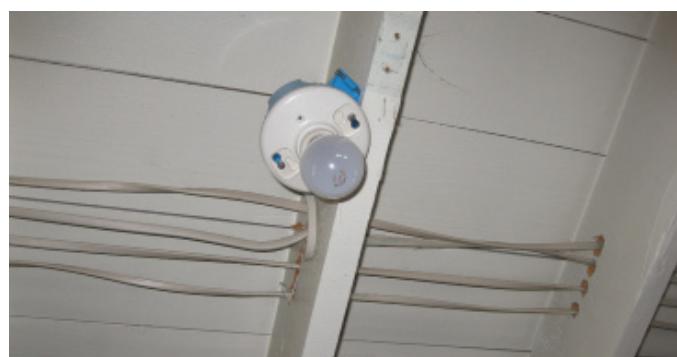
2. Accommodations were made when existing lighting was added to the building. Small holes were drilled in the ceiling beams to allow for wiring of the lighting system. This simple system can be left as is, with updates as needed to maintain the safety of the electrical system.

FR&T Building lighting, 2014

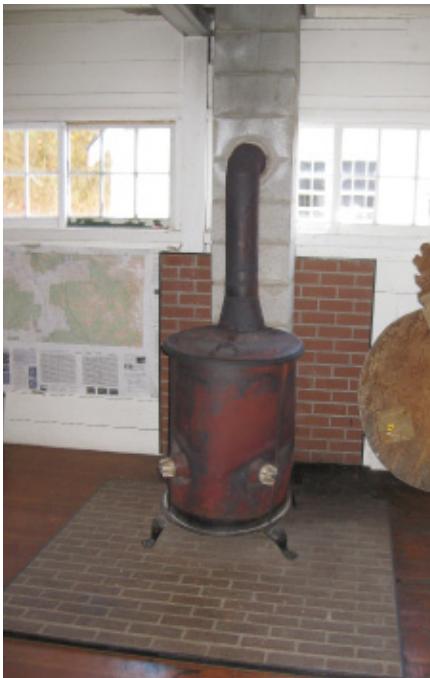
Wood burning stove with brick hearth, 2014

Additional Features of Floor One of the FR&T Building Continued:
3. The woodfire stove is likely not original, but a similar heating stove was in the same place earlier in time based on the location of the chimney. The first floor is used as an office by the Interagency Hotshot Crew and the stove helps keep the temperature in the room up in colder months. The stove rests on a brick hearth and is connected to a chimney of 16" square standard chimney block. This stove should be maintained and monitored for safety. If the stove is replaced it should be replaced in the same place in the room to attach to the existing chimney, and should be in a style that is in keeping with the period of significance.

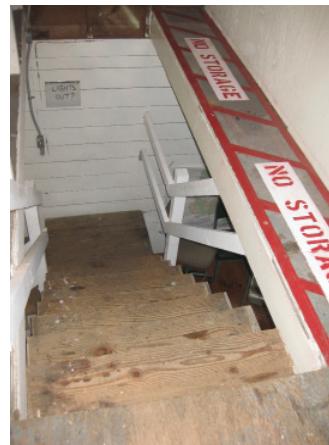
2. The second floor maintains the original wood plank flooring like the first floor. The second floor is unfinished, and has been painted in some areas for safety purposes. The unfinished floor is indicative of an area used as a shop. The flooring should be left unfinished and unpainted. If parts of the floor need to be replaced they should be replaced in kind with the remaining floor boards.

Painted and unpainted wood flooring, 2014

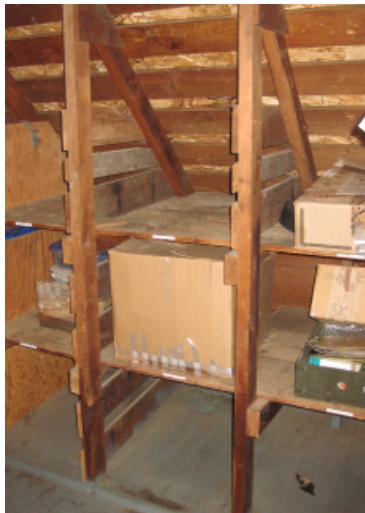
3. The second floor features exposed structural elements, which is in keeping with its use as a work area. Skip sheathing and oriented strand board (OSB) are visible beneath the recently replaced roof. In some places these elements have been covered by plywood. Covering of these elements is not required, but does not detract from the feel of the space. It is suggested that, to maintain visual consistency, the skip sheathing remain visible or is covered up throughout the floor.

Exposed skip sheathing and OSB can be seen above storage shelves, 2014

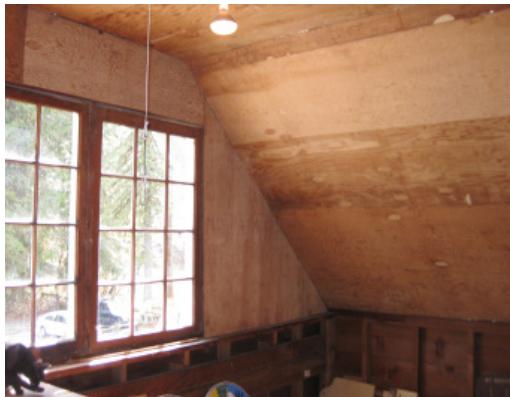
Plywood ceiling covering skip sheathing and OSB, 2014

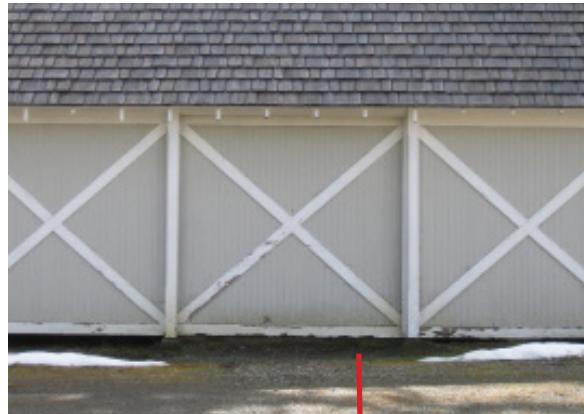
Northeast elevation, 2014

1. Eight sliding bay doors with cross bracing.
2. Exposed rafter tails, visible below the roofline.
3. Chamfered support poles, attached to the building on one side, resting on cement piers.

1. These eight bay doors are significant because not only are they the most prominent defining feature, but they are also indicative of a working building, historically used to house vehicles and machinery. These doors should remain in working order. The base of each door has been exposed to moisture, and has caused the wood to begin to wear. The area around the base of each door should be cleared of natural debris and soil to decrease risk of degradation to the doors. Areas where the paint has worn or chipped off should be repainted using a weather proof paint to protect the wood.

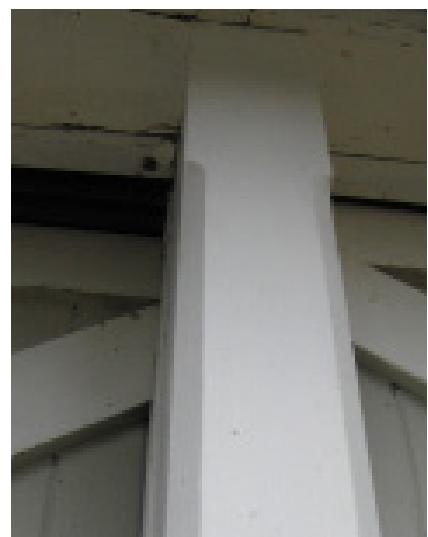
3. Chamfered support poles separate the individual sliding bay doors on the facade of the Equipment Storage Building. These supports, which rest on cement piers match chamfered poles which support the extended roof of the FR&T Building. These supports are in good condition, but should be regularly checked for signs of degradation. Care, maintenance or replacement should be in keeping with the period of significance, in kind with the current style and materials.

Chamfered corners are a subtle detail on the poles which separate sliding bay doors, 2014

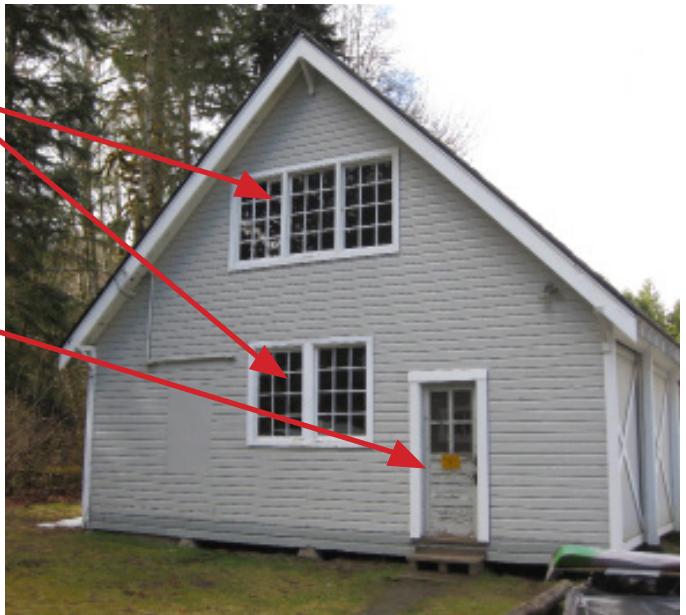
Southeast elevation, 2014

1. The set of two windows were installed between 1936 and 1942, and therefore are not original, but are significant and historic. The set of three top windows are likely original. These windows are all historic and should therefore be maintained. For care, maintenance and repair of original windows see the Department of the Interior's Standards for Restoration of Historic Properties.

2. The door, assumed to be original, should be maintained by repainting the exterior to protect the wood where paint is missing. The base of the door is quite worn, likely because of many years of use and wear. If the door needs to be replaced, replace in kind to be in keeping with the period of significance. The door frame is not flush with the siding. This is mostly cosmetic, but it is possible that moisture could be trapped between the siding and the door frame, causing the wood on both to degrade. If replaced, this frame should be pushed against the siding to close this gap. Stairs leading to the door have likely been replaced, and are not a defining feature of the entry.

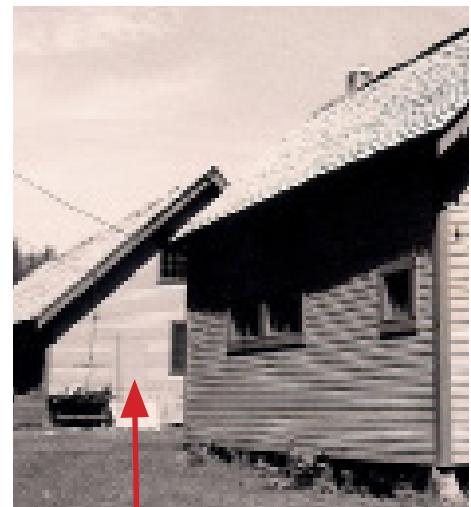
1. This elevation historically featured one more 12-pane TDL 34" x 54.5" window, located to the left and slightly below the set of two similar windows. This window can be seen in photographs from 1936, and therefore it is likely original. Between 1976 and 1985 this window was removed, and replaced with a plywood board, and painted like the rest of the exterior. The missing window is not especially noticeable. If the window were to be restored it would need to be replaced in kind. If major work is done to the exterior, consider replacing the plywood board with missing/covered window with horizontal drop siding to match the siding of the rest of the structure.

Removed window, 1985

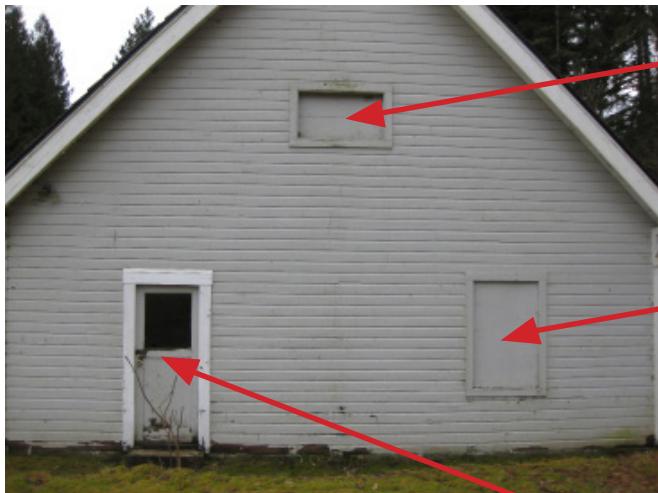
1. One missing wood frame TDL window measuring 37" x 28". This window has been missing since before 1976. The wood frame is still intact. If the window is replaced it should be replaced in kind with the period of significance.
2. One missing wood frame TDL window measuring 34" x 54.5". This window went missing between 1991 and 2014, because it is listed as having glass in the NRHP nomination form. The window frame is still intact. If the window is replaced it should be replaced in kind with the period of significance.
3. The door of this elevation is possibly original, but the window has been replaced. What used to be a 4-pane TDL window is now a single pane. If the door is replaced it should be replaced in kind with the period of significance. Having a multi-pane window is more inkeeping with the construction style of the CCC and the overall feel of the Koma Kulshan Ranger Station site.

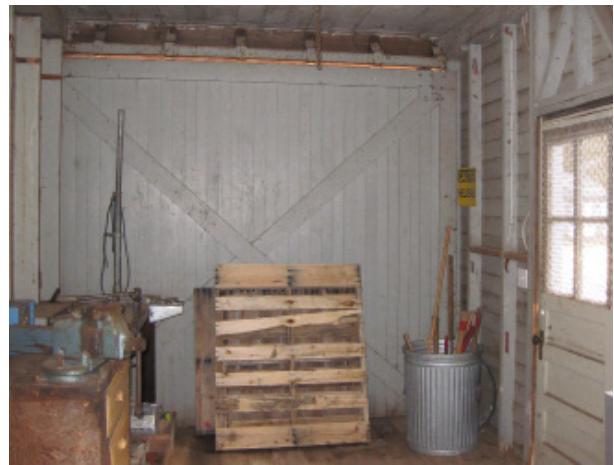
1. The key defining features of the Equipment Storage Building are the eight sliding bay doors, which are not only original but also are indicative of the purpose of the building as a working building. Work should be done to keep the area in front of the doors clear in order to avoid unwanted damage to the original wood. Where possible, maintain the original wood and metal hardware, which should be cared for as necessary, on the doors and keep the doors in working order (able to open and close).

Sliding bay doors, as seen from the interior, 2014

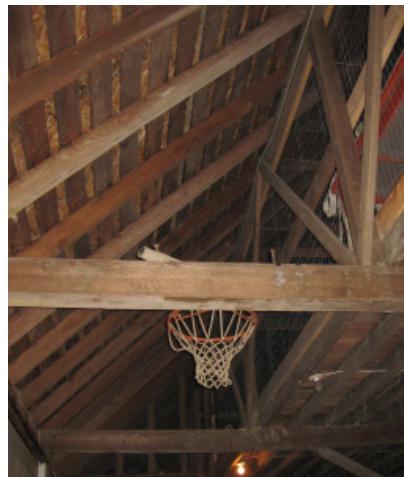
Exposed structure, 2014

2. The interior features significant exposure of structural elements including original beams, bracing, unpainted boards, replaced skip sheathing and oriented strand board (OSB) which underly the new roof. All of these features are associated with a working building where little emphasis would be put on ornamentation. These features should be checked regularly for structural integrity and signs of degradation.

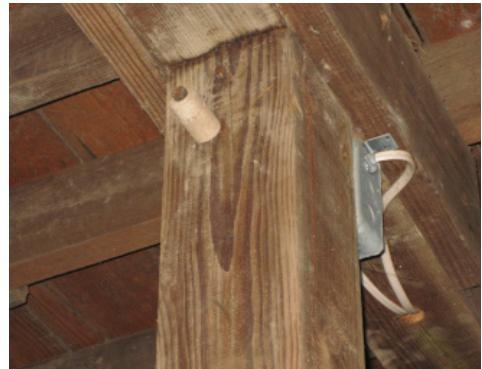
3. The vertical support posts are assumed to be original because glass insulators which would have been used for the original wiring of the building can be seen attached to the posts. This detail should be retained as physical and visual evidence of the history of the building.

Glass insulator, 2014

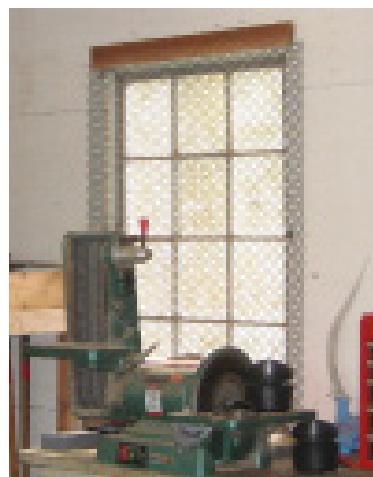
Thick wire mesh, 2014

1. Windows which face southwest in bays 6 and 7 are covered using a thick wire mesh. The same mesh can be found on the southeast exterior door window to protect equipment stored within the building. The mesh does not have a significant impact on the interior of the building, and because it is for the purpose of security should be allowed to stay in place.

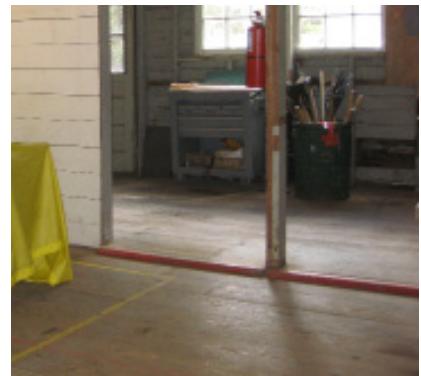
2. There are three types of flooring within the Equipment Storage Building: concrete, soil/natural, and wood board. It is likely that all bays originally had dirt flooring, since finished flooring would not be needed for the purpose of vehicle storage. Bays 1, 2, 3, and 6 have since been converted to concrete flooring, while Bays 7 and 8 now sport a wood floor which was likely installed when this area was converted to a helitack office. Bays 1 and 2 are now a combination of an exercise/weight training facility for the Interagency Hotshot Crew, and vehicle and equipment storage. Bay 3, in addition to Bays 4 and 5 which have bare soil floors, are used for vehicle and equipment storage. There are slight steps between the wood floors between Bay 8 and Bay 7, and a slight step between Bay 7 and the concrete floor of Bay 6. The flooring is not a major contributing factor in the feel of the building, and can change as appropriate for the use of the space. If flooring is not necessary consider retaining bare soil floor.

Wood board flooring in bays 7 and 8, 2014

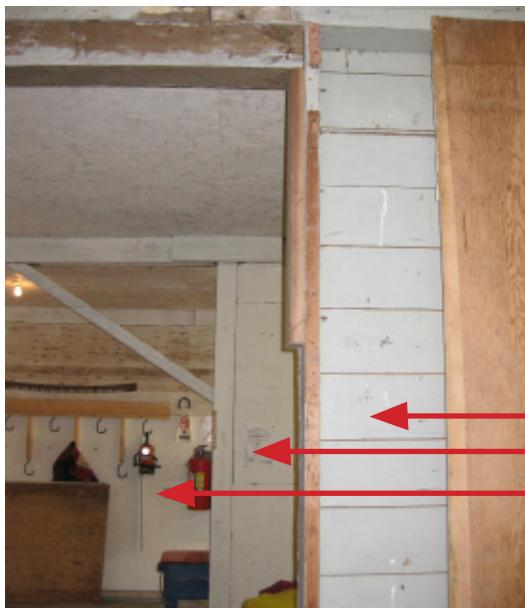
Walls installed in Bays 8, 7, and 6, 2014

3. Bays 6, 7 and 8 are separated from the other bays by a plywood wall to keep the equipment stored in these bays secure. Although not in keeping with the original open floor plan of the building, this feature is for the purpose of protecting expensive equipment for the Interagency Shotshot Crew and should be allowed to remain in place. Partial walls of horizontal boards have been installed between Bay 8 and Bay 7, likely during the same time period the wood flooring was installed and the space was converted to a helitack office. These partitions neither add nor detract from the space and can be allowed to remain.

- Partial horizontal board wall between Bay 8 and Bay 7.
- Partial horizontal board wall between Bay 7 and Bay 6.
- Full plywood wall between Bay 6 and Bay 5.

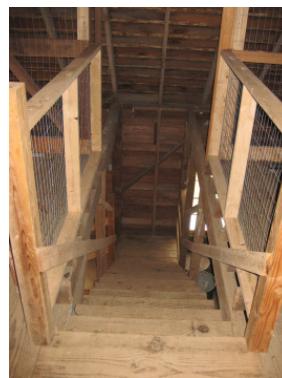
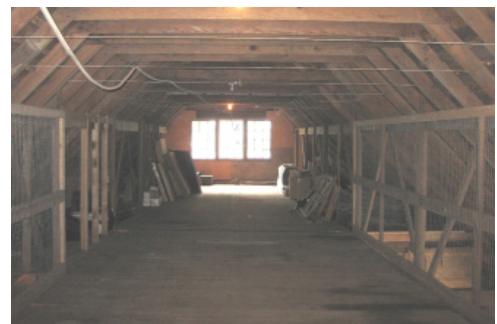
Staircase which leads from ground level floor to loft, 2014

Loft with wood and metal mesh railings, 2014

4. It is not documented whether the loft in the Equipment Storage Building is original or not, but it is listed in the NRHP Registration Form and because of its age has added to the documented character of the building. This loft led to accounts that the building was originally a horse barn, but this was later disproved. The loft floor is constructed of unpainted horizontal wood boards. The boards appear to be the same boards used when the loft was originally constructed. The loft runs the length of the building and is enclosed by a wooden railing with thin wire mesh. The wooden staircase leading up to the loft appears to have been recently replaced and meets current safety needs. The materials and style of the staircase are in keeping with the style and feel of the loft.

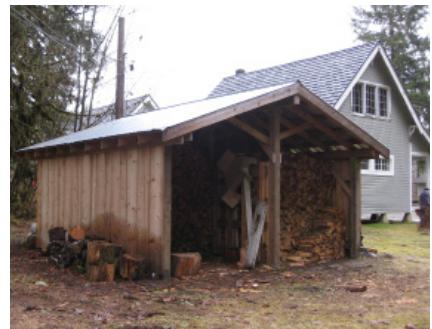
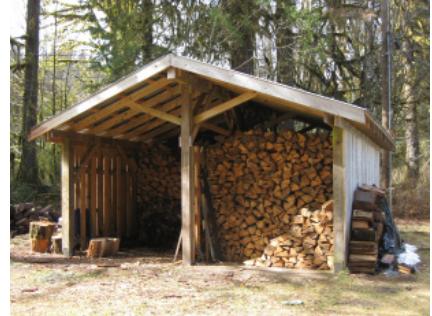
The newly constructed woodshed at the site is positioned between the Residence building and the FR&T building. Construction design and materials of the woodshed are not in keeping with the historic feel of the site, and disrupt the continuity and relationship between the historic buildings. However, the woodshed is solidly built, and a need for a woodshed on the site exists. There are two alternative approaches to addressing the woodshed, each of which is appropriate in addressing the future of the site.

Top and bottom: Newly constructed woodshed, built on concrete pad with materials not seen on remainder of the site, 2014

A. The woodshed could be demolished and rebuilt in a different location and in a style more inkeeping with the historic feel of the site. The new location of the woodshed should be discreet so as not to draw attention to the structure. Clearing an area behind the FR&T building is one suggestion. When the woodshed is rebuilt it should be in a style and with materials that are similar to those used elsewhere on the site, again discreet so as not to draw attention to the feature.

B. A second option would be to retain the woodshed as it stands now, but not take action to repair or upkeep the structure. This would allow the woodshed to continue to be used until it has naturally degraded. Once the structure is no longer fit for use a replacement woodshed would be built in a new location and with materials inkeeping with the rustic architecture of the site.
